ACTION PLAN FOR RESTORATION AT AMBOHILERO FOREST, MADAGASCAR, AND SIMILAR AREAS OF DEGRADATION

Aug. 30, 2007

Sarah Karpanty, Ph.D.
Department of Fisheries and Wildlife Science
Virginia Polytechnic Institute and State University, Blacksburg, VA, 24061 USA.
Phone: (540) 231-4586. E-mail: karpanty@vt.edu

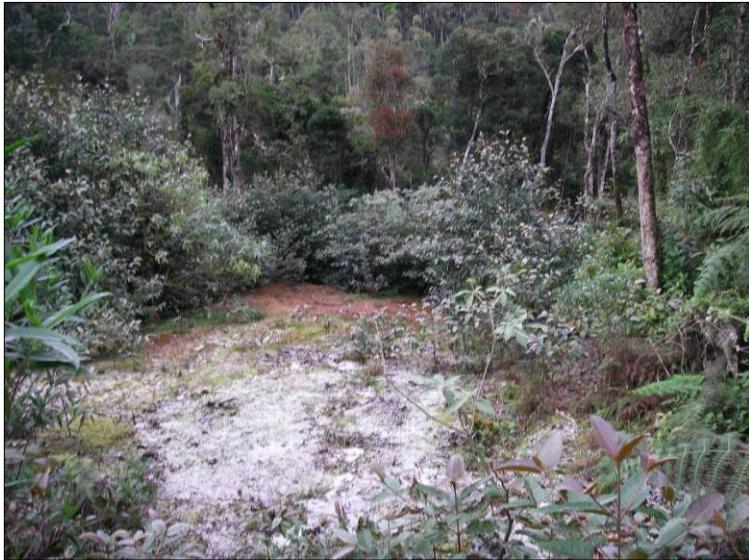
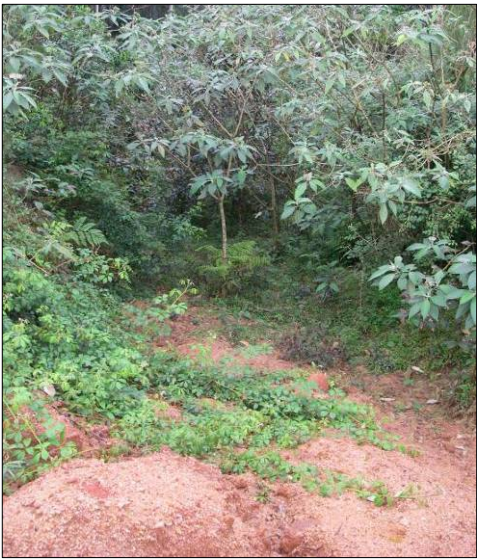
Figure 6: Observed passive revegetation of secondary logging roads DS 14 (a) and DS 26 (b).

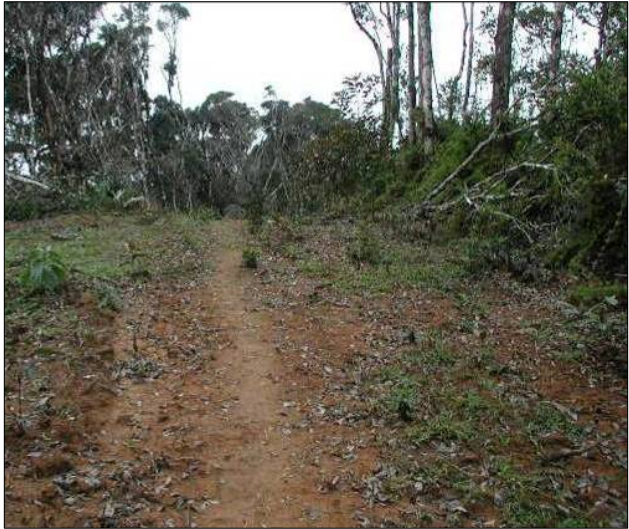
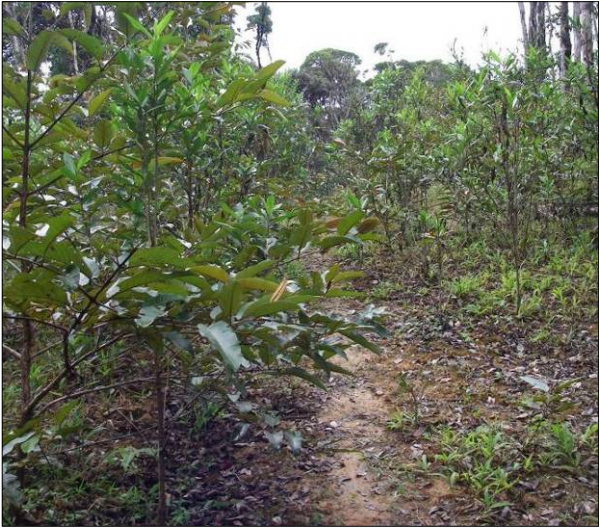
Figure 7: Change in vegetation due to passive revegetation along secondary logging road (photo plot DP2A) in 2005 (a) and 2007 (b).

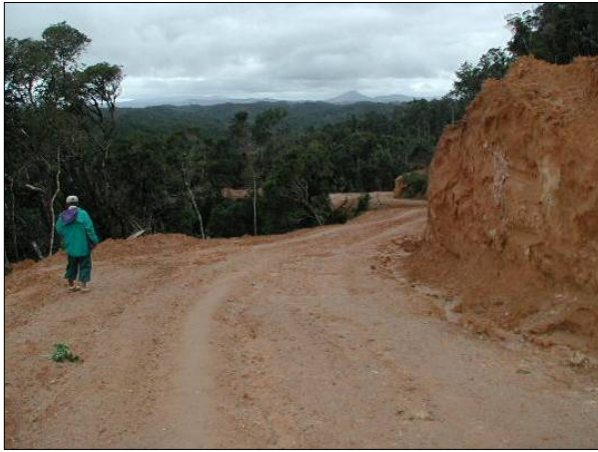
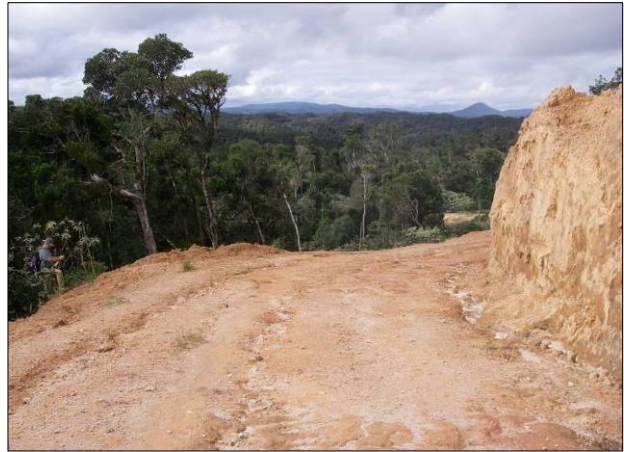
Compacted primary road plots (e.g., Figure 8 a-b) have changed little since 2005, while the sides of the primary road as well as the secondary and tertiary roads with lesser compaction have seen extremely rapid growth of pioneer species such as *Harungana* and *Solanum* despite the apparent absence of humus and topsoil. In many areas, we observed more than 3m of tree growth in the two years since our last observations. We are currently conducting analyses that will directly quantify the rapid growth rates of species in these plots over these two years, and we will publish that data when completed. We were surprised to find very few non-pioneer or primary

Figure 8: Lack of revegetation along a highly compacted section of the primary exploitation route (photo plot DP17A) in 2005 (a) and 2007 (b).

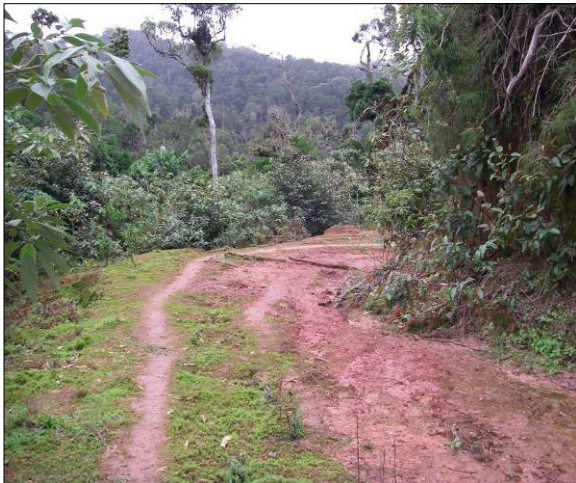
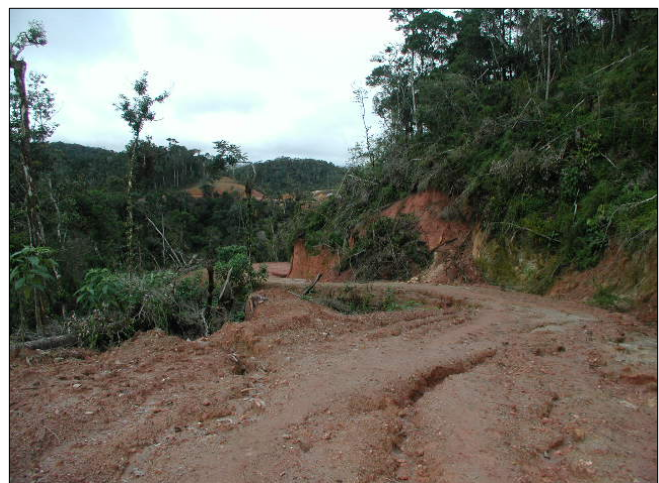
Figure 9: Partial revegetation along a compacted section of the primary exploitation route (photo plot DP9A) in 2005 (a) and 2007 (b).

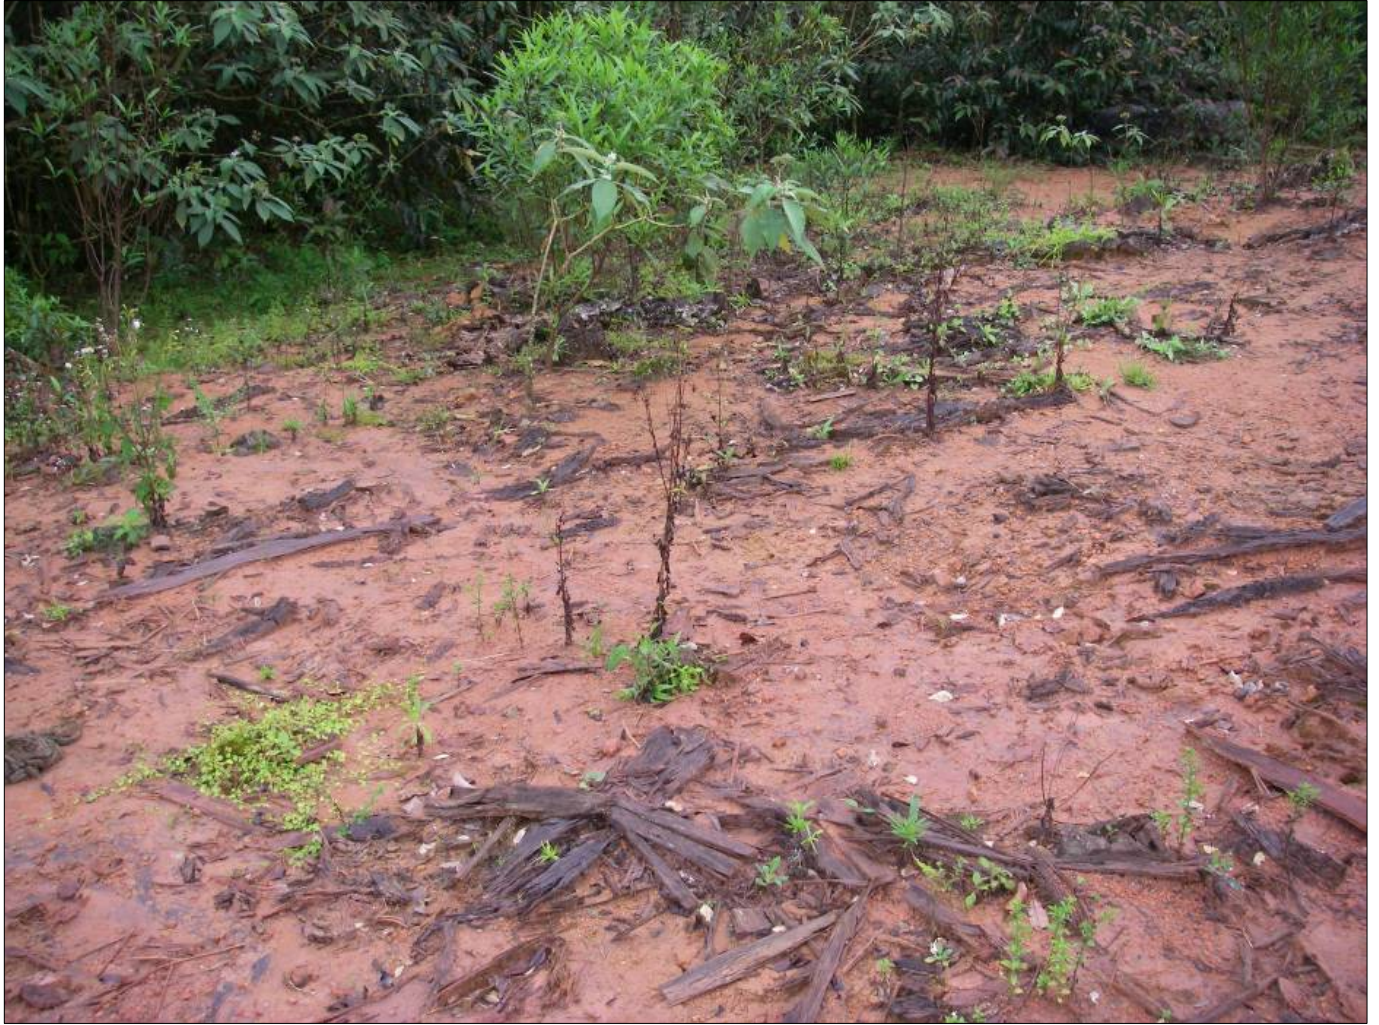
We found that any natural mulch, whether zebu dung or organic plant material (Figure 10), greatly facilitated establishment and growth of tree species on the highly compacted main road. Given that large-scale plowing of the road to loosen the soil is unlikely (and not recommended due to the potential to increase erosion), we recommend encouraging natural mulching in as many areas as possible to facilitate passive restoration.

Figure 10: Area with natural mulching (e.g., organic debris, zebu dung) showing enhanced tree establishment and growth along the primary road of exploitation.

- Encourage natural mulching, whether zebu dung or organic plant matter, along the primary road to facilitate seedling establishment and tree growth.

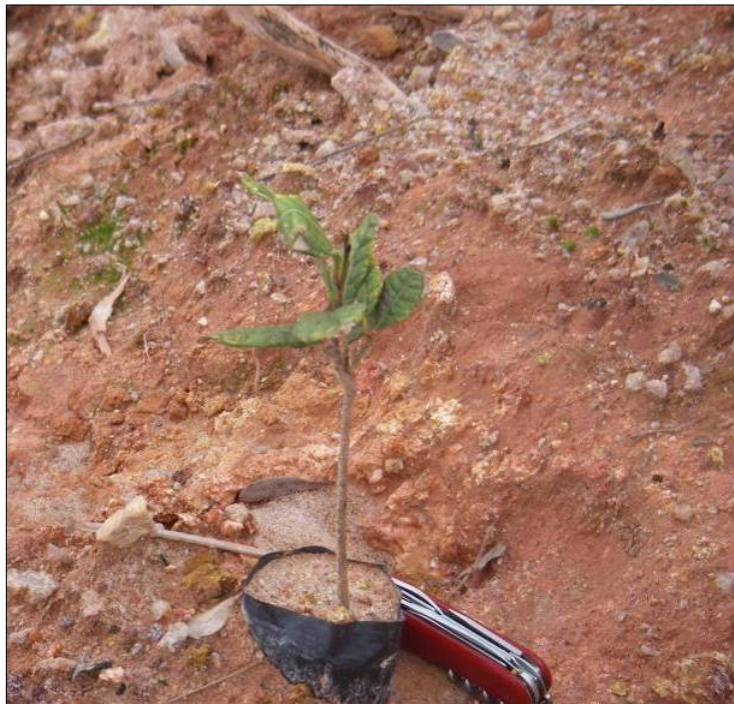
Figure 11: Trees planted by Avotr'Ala with plastic pots still encasing the seedlings.

(Figure 11). The fact that Avotr'Ala did not remove the plastic potting bags when the plants were placed into the soil has greatly inhibited their growth and likely resulted in their eventual mortality. In most locations, we recommend that MIARO staff or contractors dig up the planted trees, un-bag them, then replant them so that they have a better chance of survival. Given that so few trees were planted, this task could be accomplished in a few days by a team of two individuals.

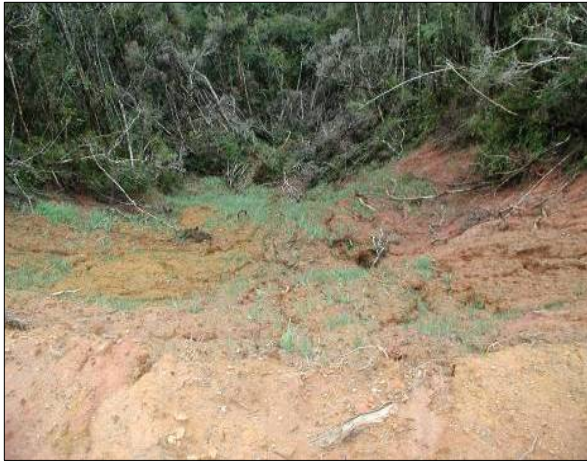
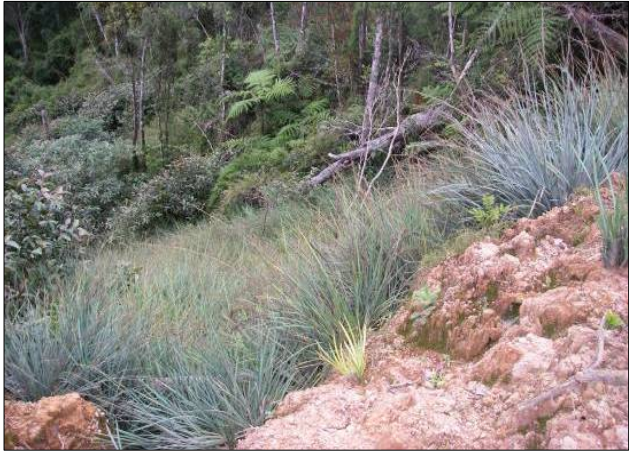
We were surprised to find that a plant identified as rangaza, a bunch type of grass, provided the best observed technique for erosion control (Figure 15). We have not yet determined the plant's scientific name, and we recommend that future expeditions collect proper specimens for formal identification. We recommend using rangaza to control gully growth and to fortify unstable slopes. Rangaza can be transplanted into gullies to form a living grade stabilization structure. It is naturally revegetating and stabilizing some steep slopes, a process that could be accelerated with transplanting. Rangaza appears to be quite hardy and able to grow in the most highly erosive situations. However, it did not appear to grow in highly compacted

Figure 14: Natural rangaza growth. Site in 2005 (a), and the same site largely stabilized in 2007 with rangaza (b).

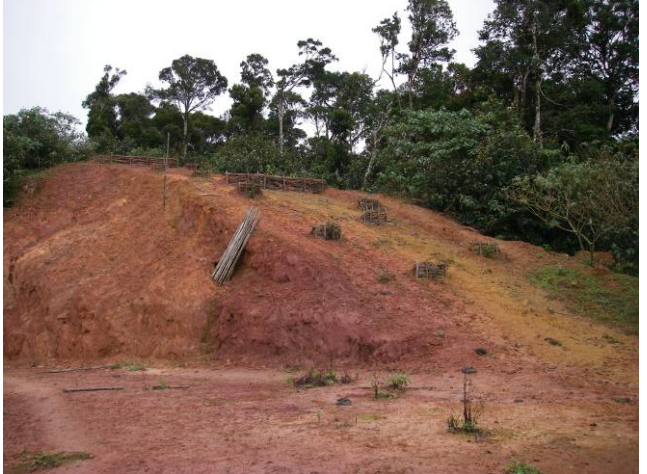
Site ID	GPS S	GPS E	Recommendation	
A1	17°59'12.5"	48°35'05.5"	Intervention on slope up to old Malagasy logging road. Some natural regeneration in zebu dung and 18 planted trees are doing okay. We recommend un-bagging the trees and reinforcing existing barrages with rangaza as a naturally regenerating barrier to erosion.

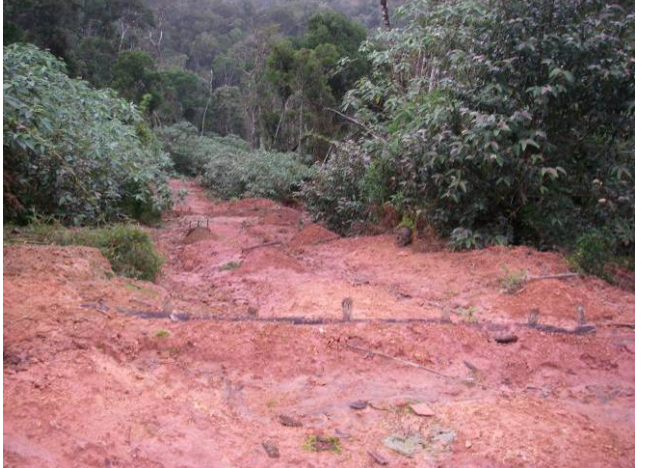
A2/R7	17°59'04.3"	48°35'05.2"	Tree plantings are doing well on this secondary road. Recommended reforestation site R3. It is a good area for additional plantings, but water bars should be added about every 20 m in the steeply sloping portion of the road adjacent to the main road. Encourage ground cover such as vines and rangaza to stabilize the slope.

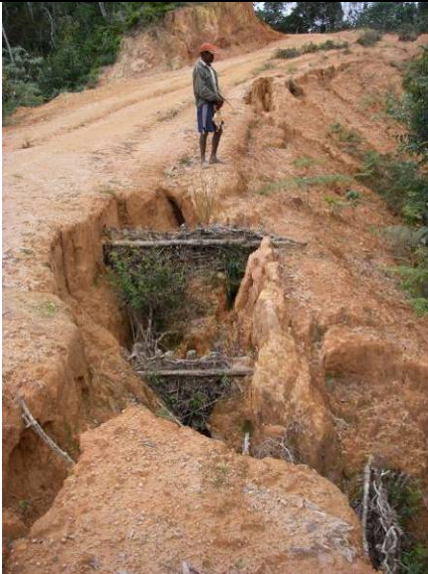
Site ID	GPS S	GPS E	Recommendation	
A3	17°57'45.5"	48°33'36.3"	Three existing barrages in gullies. It is not necessary to maintain this intervention, as it is only serving to stabilize the road, which is not desired.

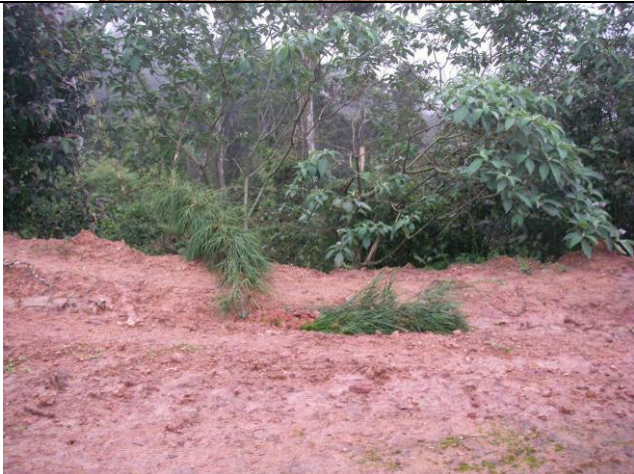
A4	17°58'40.1"	48°35'02.2"	Two of three tree plantings are still alive. Not an area in need of erosion control. We buried bamboo shoots here to determine if they might take root and naturally stabilize the soil.

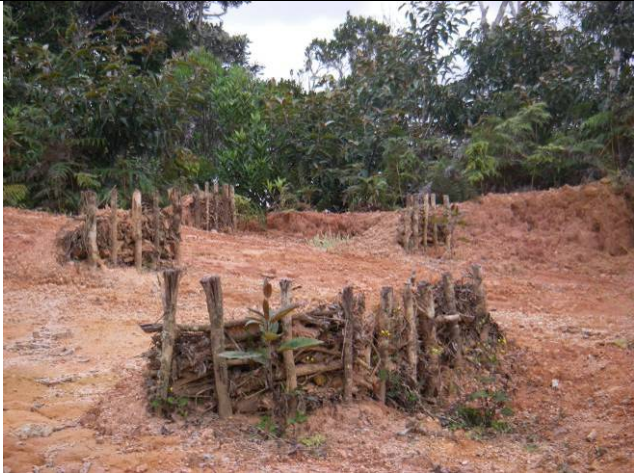
Site ID	GPS S	GPS E	Recommendation	
A5	17°57'57.3"	48°33'49.9"	Only 3 of 7 planted trees are still alive. 100 m uphill from A4. Good area of intervention, but here and in other places, we recommend using rangaza as a natural self-sustaining barrage other than the structural barrages shown here.

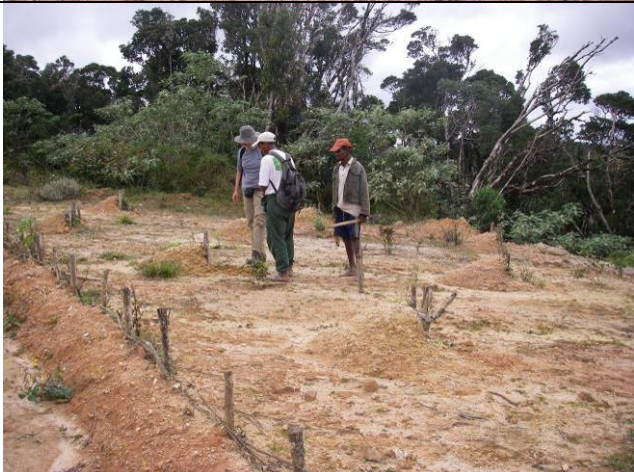
A6/R8	17°57'59.2"	48°33'56.3"	A6 is a steep slope partially colonized by rangaza with trees planted. Recommend removing bags from these trees and replanting. Recommended reforestation site R9. Large trees are closing in on either side of the road (a peak and saddle area), so this is a priority area recommended for tree planting to reestablish a tree canopy across the road. Should also place several water bars upslope of planted trees to be planted to protect the seedlings from erosion.

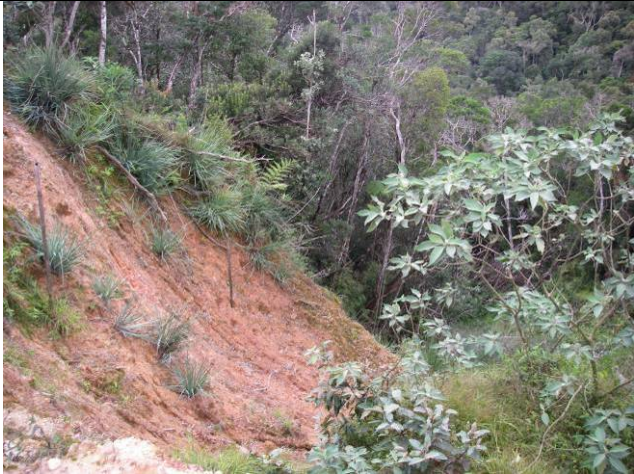
Site ID	GPS S	GPS E	Recommendation	
A7/R9	17°58'01.6"	48°34'00.2"	Steep slope with natural rangaza and planted trees. Also, long barrage along road with 10 smaller barrages and soil grafts. No trees are growing in soil grafts. We recommend monitoring the grafts, but they do not seem to be useful. This slope is steep, so we do not recommend disturbing it to un-bag trees for worker safety reasons. Rangaza is in the process of revegetating the slope. Recommended reforestation site R10. We recommend transplanting Harungana and Seva into the road bed, planting nursery trees under Harungana and Seva canopy on sides of road.

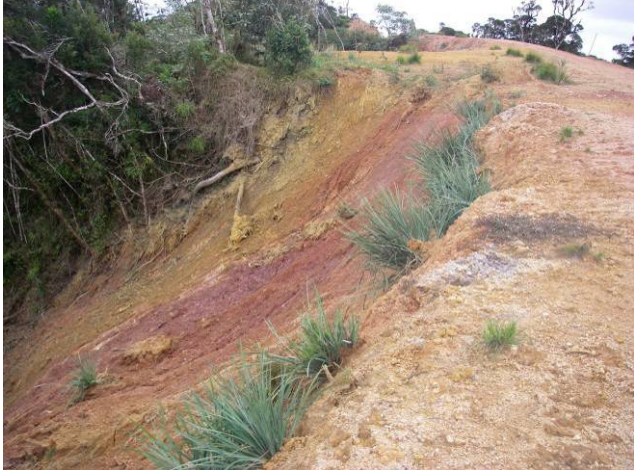
A8	17°58'09.4"	48°34'06.5"	Two additional landslide areas upslope from E10 partially revegetated with rangaza and planted trees. Should not disturb slope, may want to encourage natural vines at top of slope. Also have 10 soil grafts and tree plantings at top of hill, should un-bag and replant these trees.

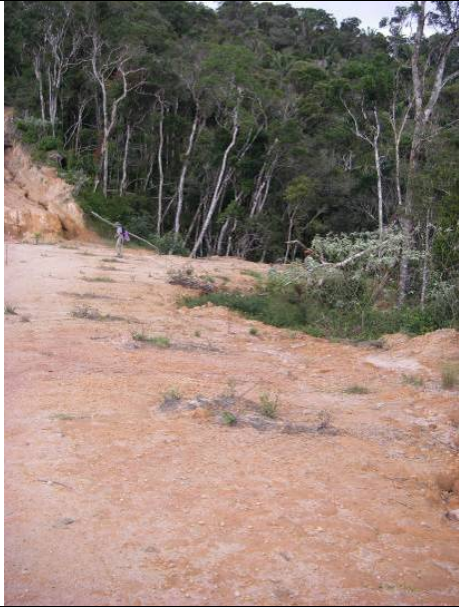
Site ID	GPS S	GPS E	Recommendation	
A9/R10	17°58'11.5"	48°34'14.7"	Site has 15 circular soil grafts on both sides of the road, 0.5m in diameter each. Some herbaceous vegetation is growing in grafts but not yet spreading. Recommend monitoring this site but not expanding. Recommended reforestation site R12 is at this location. Recommended reforestation site due to low slope and narrow gap in existing canopy of large trees on both sides of the road.

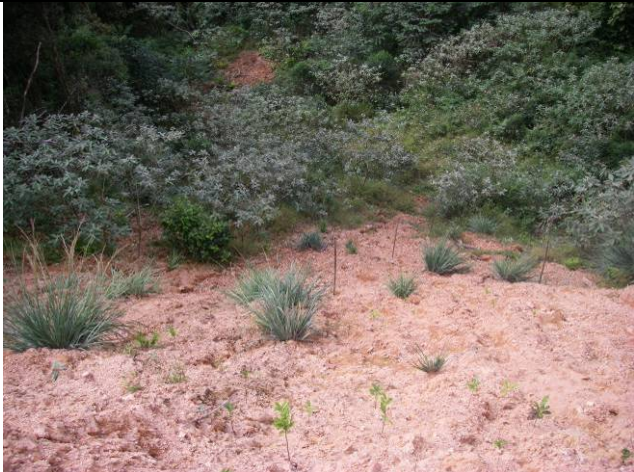
A10	17°58'12.4"	48°34'18.0"	Area with planted tree seedlings. Should remove tree bags, replant, and allow rangaza to spread. Not a priority for more planting because of wide gap in existing tree canopy.

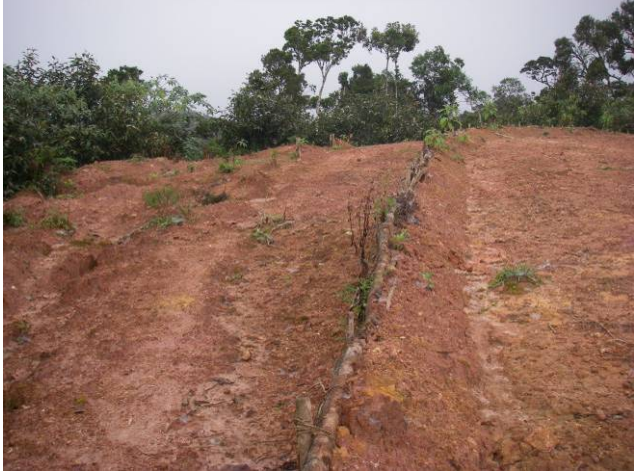
Site ID	GPS S	GPS E	Recommendation	
A13	17°58'08.9"	48°34'35.1"	Two rows of soil grafts with transplants. Not yet spreading, tree 'volunteers' in some grafts. Recommend monitoring soil grafts. Barrage runs up and down slope and is not effective for erosion control. No need to maintain.

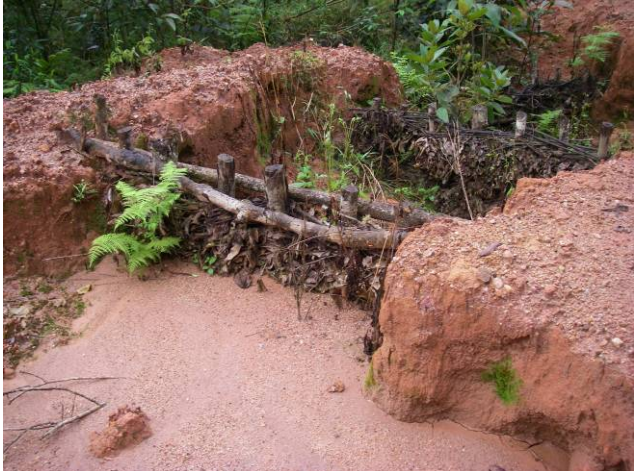
A14	17°58'12.4"	48°34'38.4"	Several barrages working well here. Could reinforce with rangaza, but not a high priority restoration site.

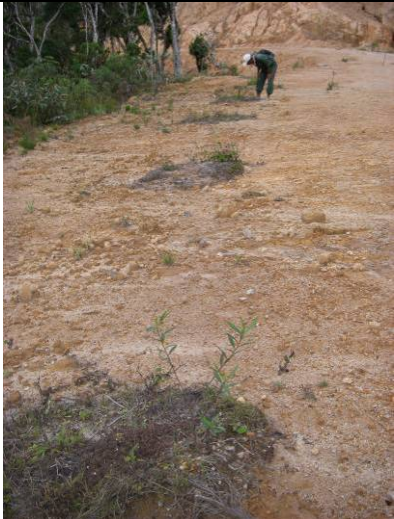
Site ID	GPS S	GPS E	Recommendation	
A15	17°58'11.3"	48°34'41.8"	7-10 soil grafts. Little evidence of regeneration from soil grafts. Continue monitoring.

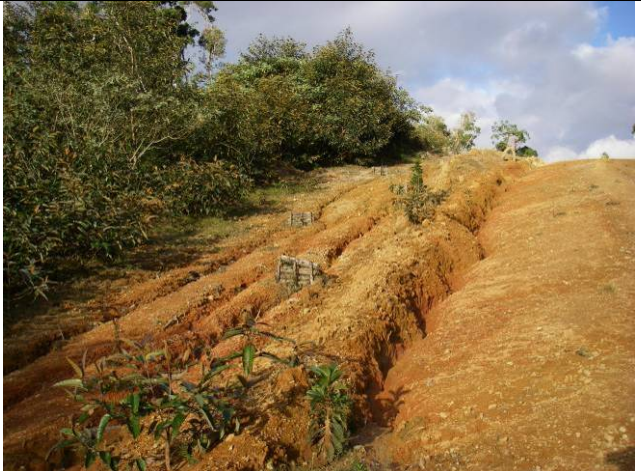
A16	17°58'19.4"	48°34'59.2"	Healthiest area of tree planting observed, with 7 of 9 trees planted behind barrages, still living. Seedlings should be un-bagged and replanted. Heavy gully formation on the left side of the road. We recommend stabilizing gullies with rangaza to protect tree seedlings. The soil grafts at this site are also doing well, with young trees growing many. Continue to monitor.

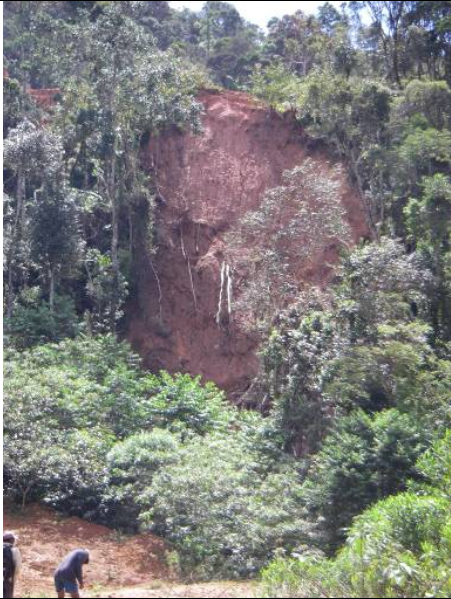
Site ID	GPS S	GPS E	Recommendation	
E1	17°59'20.1"	48°35'43.1"	<p>High priority area for active erosion control activities because unstable slope is adjacent to river and there is little buffer between the slope and river.</p> <p>Demonstration water bars were constructed here, on roadway down to Malaysian timber camp. There is no way to control the major landslide next to Sahananto River, but erosion from this slope can be limited with water bars every 20m to direct water away from the slope and disperse in what buffer areas exist. Rangaza should also be planted near the top of the steep slopes with the expectation that it will spread down slope by windborne seed dispersal.</p>

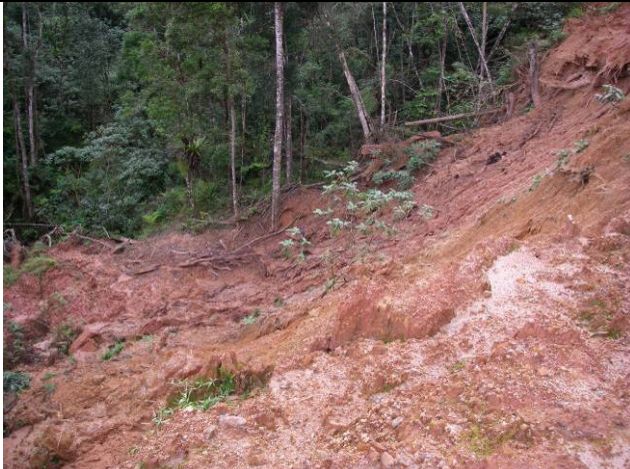
E2	17°59'18.2"	48°35'41.6"	<p>High priority area for active erosion control on roadway and steeply sloping side fill. Place water bars in road upslope between E3 and E2. Revegetate slope with rangaza. This landslide has partially dammed a small stream, creating a pond.</p>

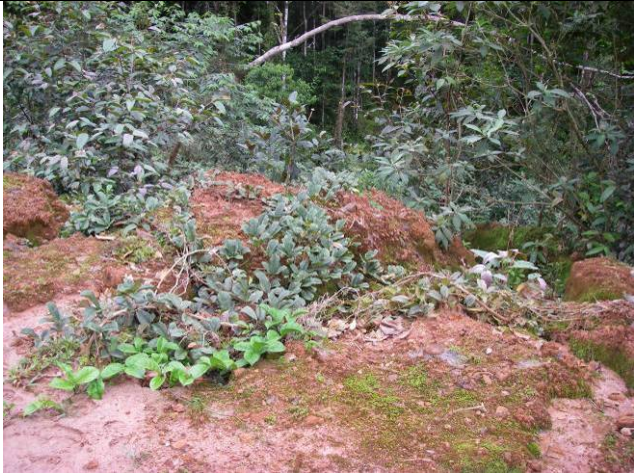
Site ID	GPS S	GPS E	Recommendation	
E3	17°59'18.4"	48°35'40.1"	E2 and E3 are less than 100 m apart. We recommend placing a water bar midway between E3 and E2, and encouraging natural vines to grow as shown here at E3. Loose ends of vines should be carefully pulled from areas adjacent to the roadway and anchored with soil.

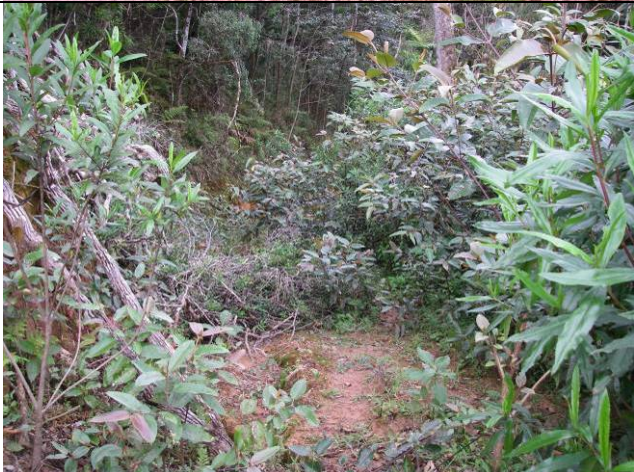
E4	17°59'20.3"	48°35'31.7"	Landslide has partially blocked the road, and revegetation is creating a natural corridor for wildlife. We recommend mulching areas without vegetation to encourage regrowth.

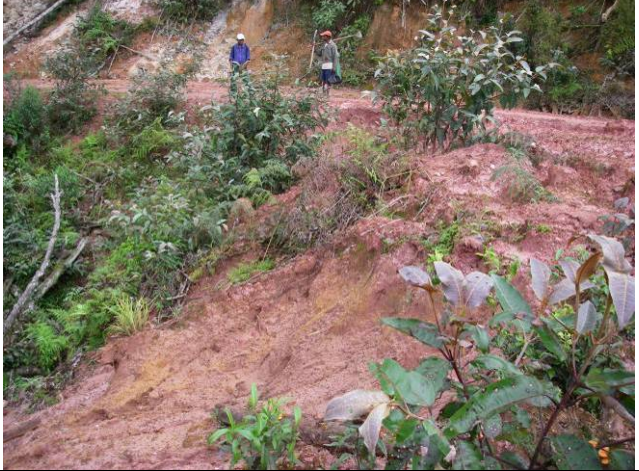
Site ID	GPS S	GPS E	Recommendation	
E5	17°59'18.5"	48°35'25.8"	Landslide area but now approaching natural stable slope, so no need for large-scale intervention. Recommend planting rangaza and encouraging vines on slope.

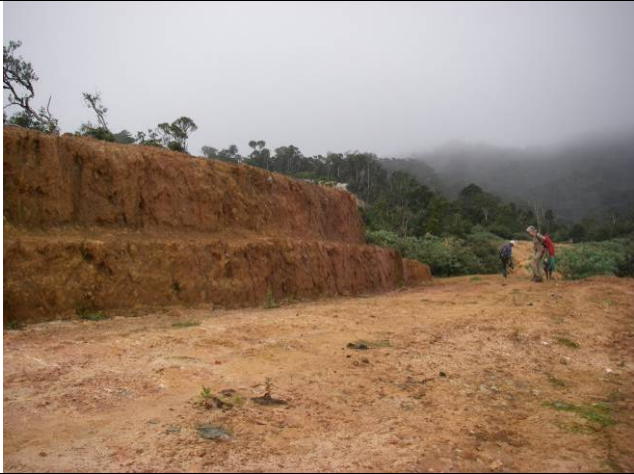
Site ID	GPS S	GPS E	Recommendation	
E6	17°58'49.1"	48°34'59.9"	There is a high wall here as a result of excavation to reduce the road slope. We recommend planting Seva and Harungana seedlings from nearby areas on top of this wall and wherever else feasible, and vines down the sides.

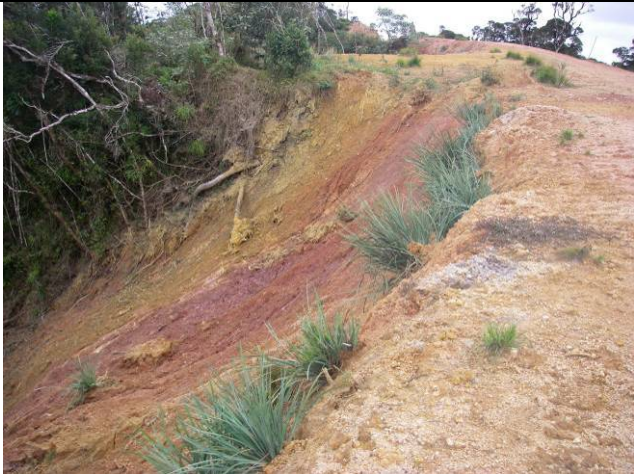
E7	17°58'09.4"	48°34'05.5"	New landslide post-cyclone 2007. Recommend planting rangaza and natives vines on slope to stabilize.

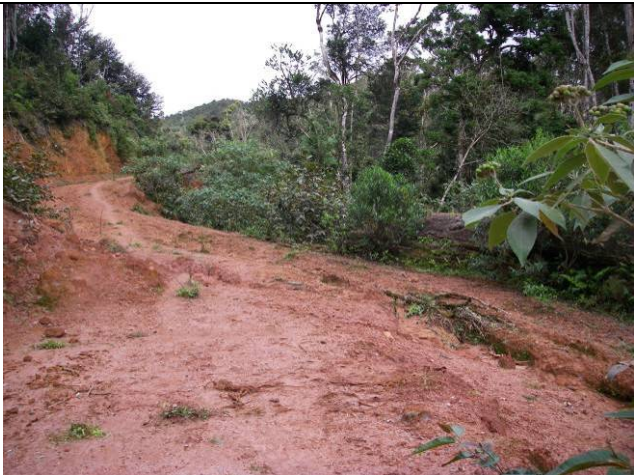
Site ID	GPS S	GPS E	Recommendation	
W1	17°59'19.8"	48°35'39.2"	Recommend installing a water bar angled so that it crosses just upslope from a pile of logs just off the bottom right corner of this photo.

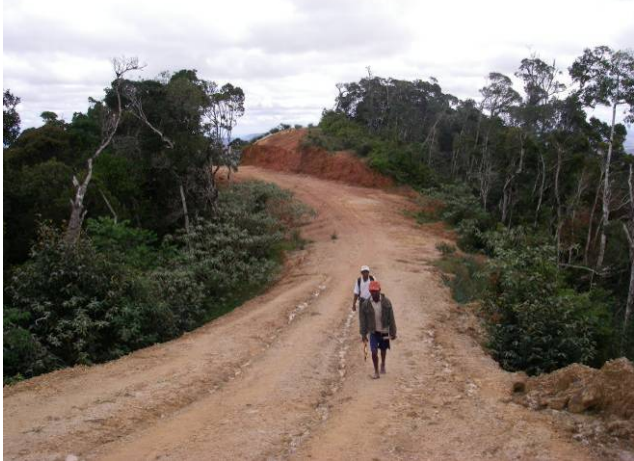
W2	17°57'59.6"	48°33'52.6"	Recommend constructing water bars at 20m intervals. Build to cover the entire road, can be placed in either direction but should depend on observed direction of water flow.
