## Sustainable Agriculture and Natural Resource Management Collaborative Research Support Program

### Trip Report: Zambia

10-20 December 2007 and 18-28 February 2008

**Purpose of Trip:** Install equipment for watershed monitoring including stream gauging stations, weather stations, and rain gauges for the four Emusa watersheds identified in March 2007. Follow up on installation of the stations and download data in February 2008.

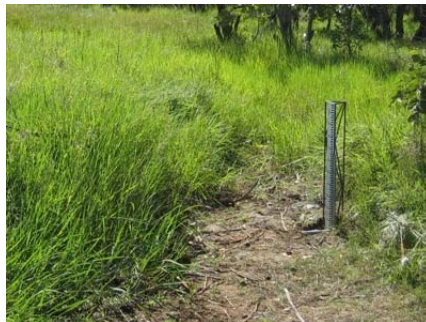
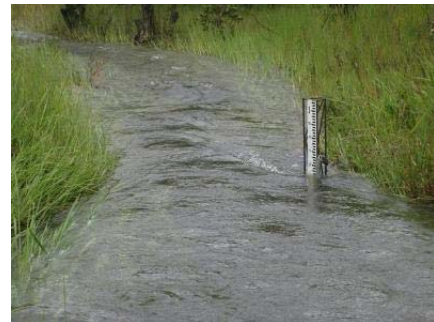
Mphiri Dambo: a) Dec. 2007

b) Feb. 2008

*Stream flow monitoring.* We are using natural stream channels, selecting monitoring locations with stable cross-sections. At each location a data-logging pressure sensor records pressure every 15 minutes. A non-vented pressure sensor is being used because of flexibility in installation options and simplicity of maintenance. A reference pressure sensor is located at Emusa (with the station manager)

which is used to ‘correct’ the stream pressure data to give water depth. Sensor sensitivity is better than 1cm. A staff gauge at each site is used by a field observer to record water depth on a daily basis for reference and as a validation of the sensor data. The stage-discharge relationship at each monitoring station is needed to convert depth (stage) to flow rate, and requires measurement of flow rate for a range of low to high flow conditions. A flow meter and stopwatch were left with White Lunga, the Emusa station manager who has responsibility for overseeing the flow monitoring. Alfred, an assistant at the center is providing the primary field observations for the 2007-2008 rainy season. An important focus of the time in the field was to practice the flow monitoring techniques using the flow meter. The salt dilution technique is not being used in these streams because the streams are generally not very turbulent. For high flow conditions when the flow meter cannot be used, a float timed over a set distance will be used to estimate flow velocity. The observation of stage will be used with the surveyed channel cross-section to estimate flow rate for peak flow events. Field observers have been recruited at each location and data from the Dec to Feb period was good.

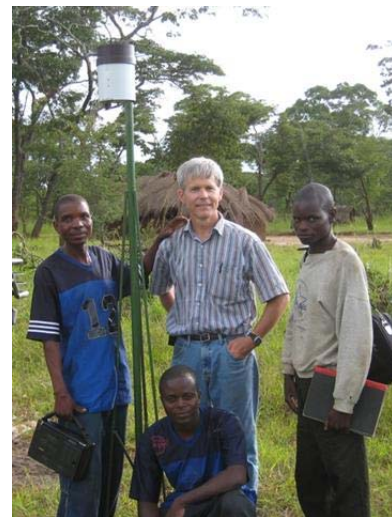
Kamatete school and rain gauge.  
(Teachers on left and right)

*Weather measurements.* A weather station (rainfall, temperature, relative humidity, solar radiation, wind speed/direction, barometer) was installed at Emusa, and a smaller station at the ZAWA camp on the Chifunda road (first 4 parameters). A recording rain gauge installed at the Chazovu school in December was replaced in February with a Davis Vantage Pro2 Plus (7 parameters). The headmaster and teachers were very enthusiastic about having the weather station. The Davis provides a real-time readout in addition to storing the data for later download by computer thus is more supportive of the school program than the Hobo instruments which provide no real-time view of the data. The Chazovu school is the central/head school for the district, so the rain gauge placed there in Dec. generated interest among all the schools of the district. Recording rain gauges (Hobo) were installed at the Munyukwa, Kamatete and Mphiri schools, again with great interest and support from the teachers. In total, 3 weather stations and 3 recording rain gauges have been deployed. In addition, there are several farmers keeping records on manual gauges throughout the general Emusa area of the watersheds.
