ACTION PLAN FOR RESTORATION AT AMBOHILERO FOREST, MADAGASCAR, AND SIMILAR AREAS OF DEGRADATION

Aug. 30, 2007

Sarah Karpanty, Ph.D.
Department of Fisheries and Wildlife Science
Virginia Polytechnic Institute and State University, Blacksburg, VA, 24061 USA.
Phone: (540) 231-4586. E-mail: karpanty@vt.edu

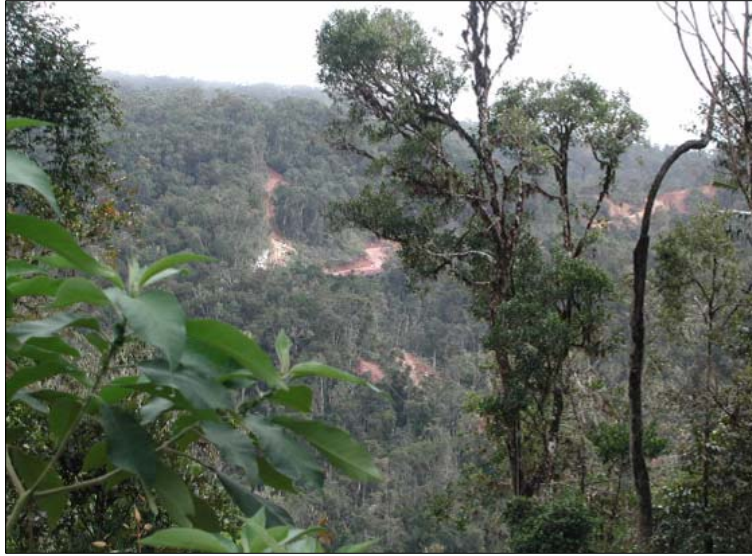
Timber began road construction and timber harvesting in April 2004, and all activities were stopped in November 2004 by order of the president. During these eight months of exploitation, Latitude Timber used heavy machinery to widen some existing logging roads from less than 3 m to greater than 10m in most places, to construct large areas of new road, and to harvest timber by clear-cutting along the edges of the newly constructed roads (Figure 2, see Karpanty et al. 2005 for details of the exploitation).

Figure 2: Main road construction and timber exploitation as seen from a view above the Latitude Timber camp in 2005 looking towards Antsevabe.

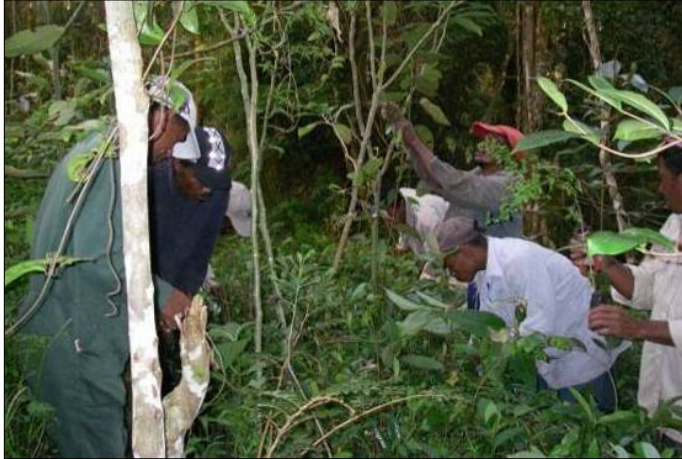
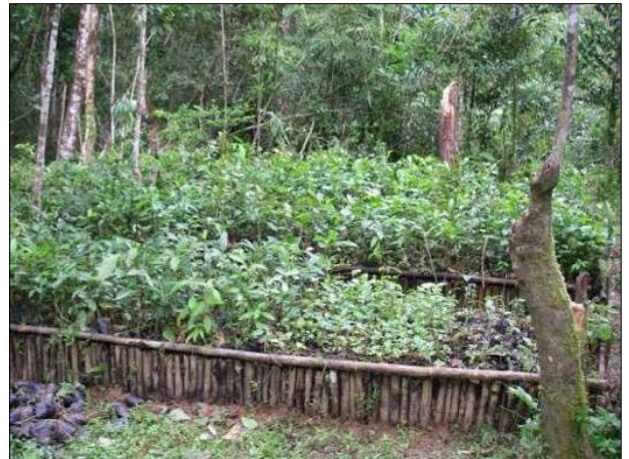
We found the two nurseries established by Avotr'Ala to be overgrown and in need of weed removal but in better condition than expected (Figure 12). We cleaned the nurseries and removed dead seedlings (about 10% of plants were dead in the nurseries, an astoundingly low

percentage considering the lack of care during the preceding months, suggesting that there could be a high survival rate when seedlings are actually planted). We found about 6,350 seedlings in good condition for planting by MIARO. Accounting for an estimated loss of 10% from within the nursery and having observed fewer than 500 planted seedlings, we could account for only

Figure 12: Tree nurseries established by Avotr' Ala before (a) and after weeding and elimination of dead seedlings (b).

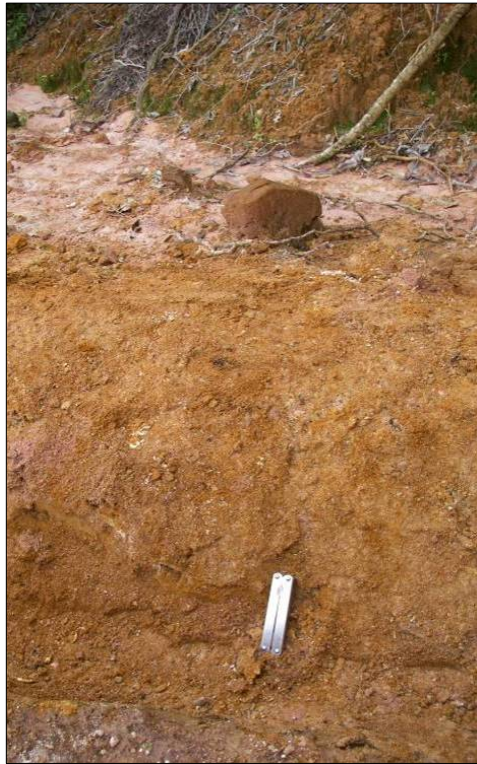
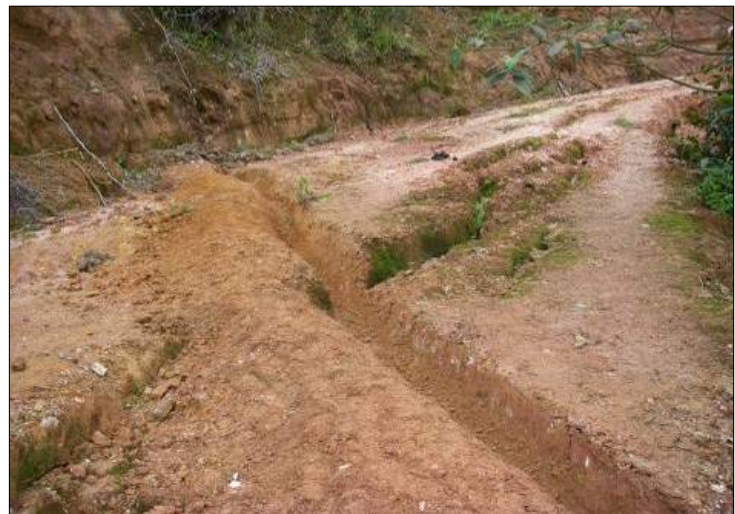
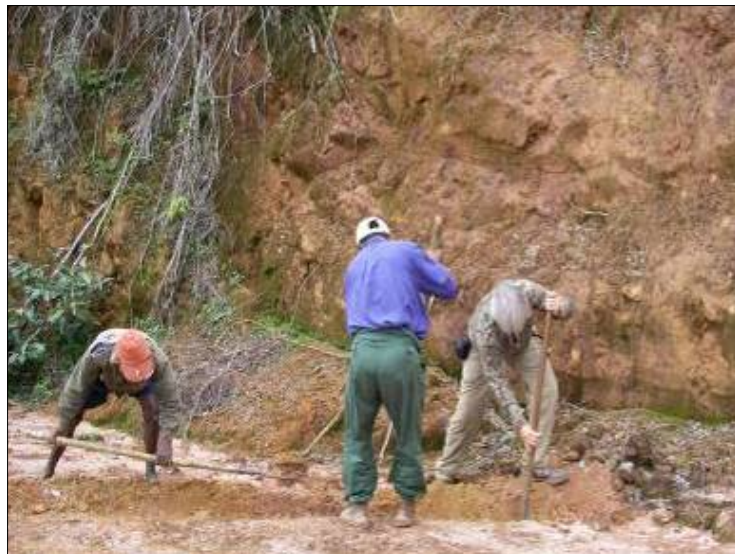
Figure 13: Demonstration water bars in areas of high soil erosion affecting important water sources or threatening tree planting. **(a)** Depth of 25 to 35 cm), **(b)** placement across the road to intercept gully and concentrated flow, and **(c)** construction.

Our recommendations for the placement of water bars and other erosion control techniques are described in Section VI. Whenever possible, we recommend mulching actively eroding areas with zebu manure and other organic debris to protected planted seedlings. We also recommend that, except on the steepest slopes, the seedling bags on trees planted by Avotr' Ala be removed and the trees be replanted.

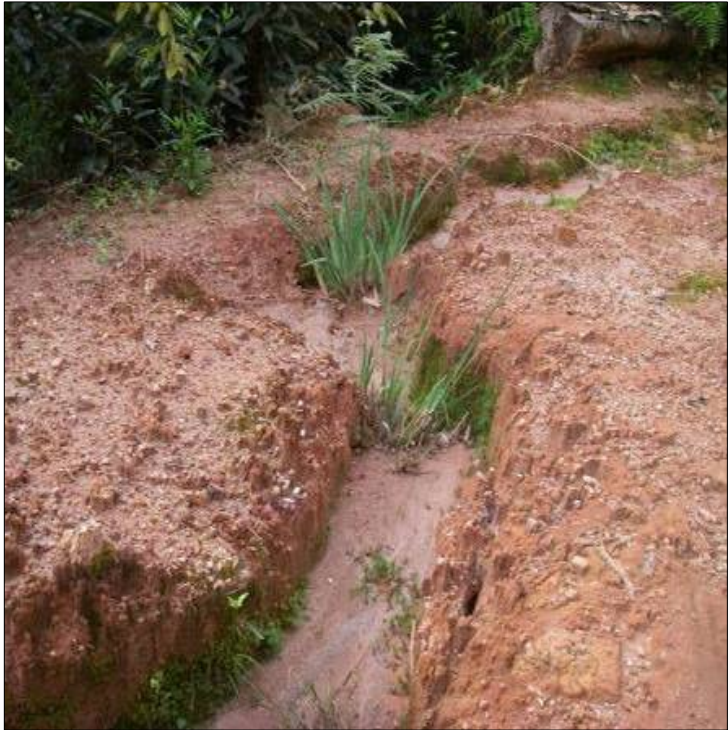
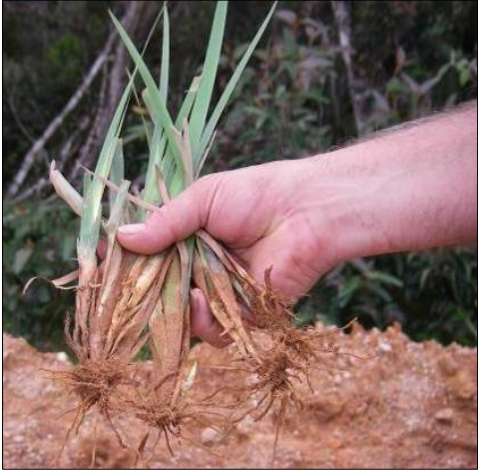
We were surprised to find that a plant identified as rangaza, a bunch type of grass, provided the best observed technique for erosion control (Figure 15). We have not yet determined the plant's scientific name, and we recommend that future expeditions collect proper specimens for formal identification. We recommend using rangaza to control gully growth and to fortify unstable slopes. Rangaza can be transplanted into gullies to form a living grade stabilization structure. It is naturally revegetating and stabilizing some steep slopes, a process that could be accelerated with transplanting. Rangaza appears to be quite hardy and able to grow in the most highly erosive situations. However, it did not appear to grow in highly compacted

areas. Large bunches of rangaza divide easily into sprigs that can be planted where needed. Our team has not observed this plant in other regions of Madagascar, but all local guides and assistants believe it to be native to Madagascar. The identification of rangaza is a priority.

Figure 15: Natural rangaza establishment and erosion control in a gully (a). Rangaza sprigs for replanting (b).

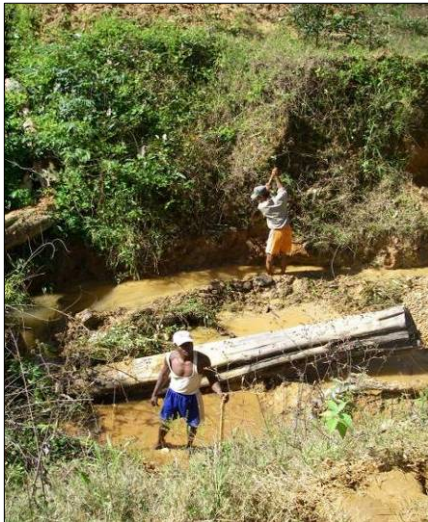
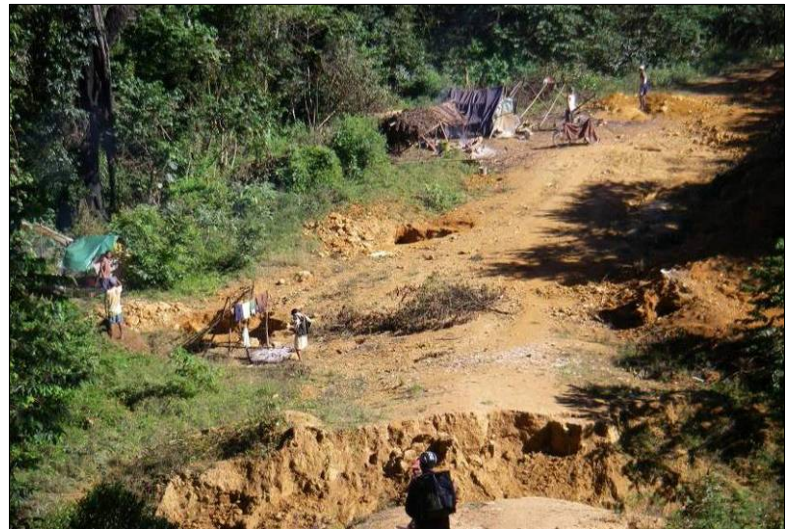
During our expedition, we saw a small gold-mining operation, led by individuals from Antananarivo, double from about five workers to more than 10 in just under six days, expanding its footprint in the Ambohilero classified forest (Figure 18 a-c). Because our team was actively working in the forest, we were able to notify the local forestry official (Chef Triage des Eaux et

Figure 18: Gold miners from Antananarivo in Ambohilero classified forest in May 2007.

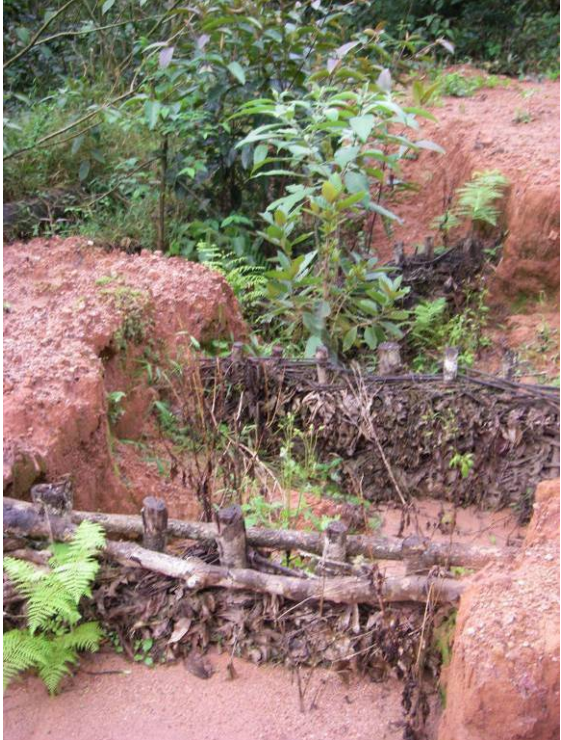
Site ID	GPS S	GPS E	Recommendation	
A13	17°58'08.9"	48°34'35.1"	Two rows of soil grafts with transplants. Not yet spreading, tree 'volunteers' in some grafts. Recommend monitoring soil grafts. Barrage runs up and down slope and is not effective for erosion control. No need to maintain.

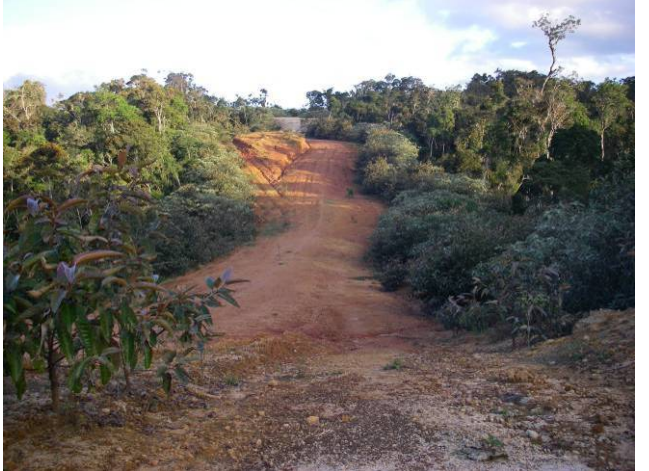
Site ID	GPS S	GPS E	Recommendation	
R1	17°58'24.0"	48°35'02.4"	Good saddle area for tree planting to create a corridor. We recommend placing water bars every 20m to facilitate tree growth.

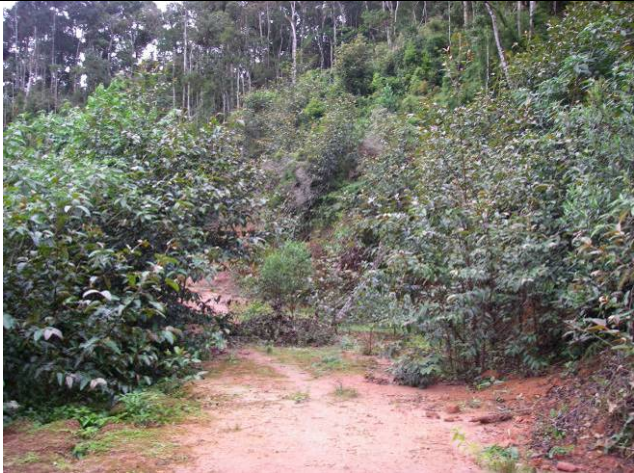
Site ID	GPS S	GPS E	Recommendation	
R2	17°59'15.2"	48°35'18.2"	Natural corridor starting to form in a relatively flat area, so good for targeted tree planting. We recommend mulching and additional tree planting.

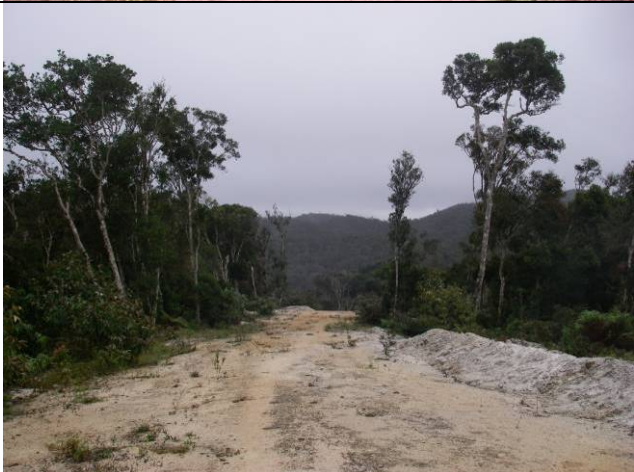
R3	17°58'56.7"	48°35'03.6"	Recommended spot for active corridor restoration, as there are large trees on both sides of the road. Plant combination of forest trees, Seva and Harungana.

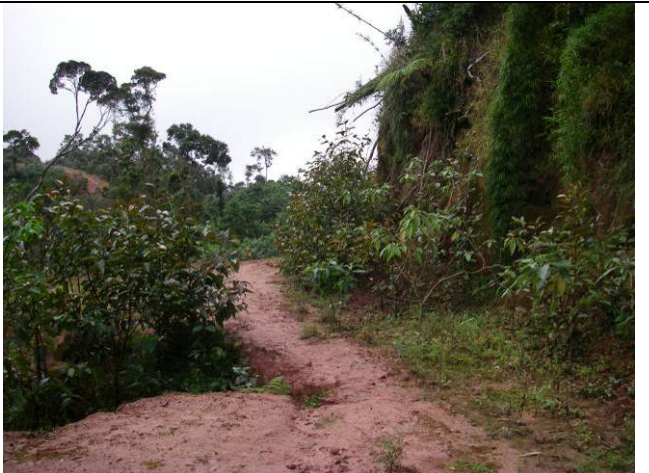
Site ID	GPS S	GPS E	Recommendation	
R4	17°57'45.5"	48°33'36.3"	Recommended site for active reforestation to restore wildlife corridor. Currently there is a 7m wide gap in the canopy, with large trees on both sides of the road. Top of saddle. Located between DP21-20	No photo available
R5	17°58'09.8"	48°34'07.4"	Recommended site for active reforestation to restore wildlife corridor. Currently there is a 7 m wide gap in the canopy, with large trees on both sides of the road.	No photo available
R6	17°59'15.7"	48°35'06.4"	Recommend tree plantings and mulching at this site to assist in closure of a natural corridor, which is less than 1 m wide.
